Condenser Seal/ Hood Bellows Emergency Repairs

Recently a customer was having a significant leak in the hood bellows and needed an on-line fix in order to make it to their scheduled outage for the following month.

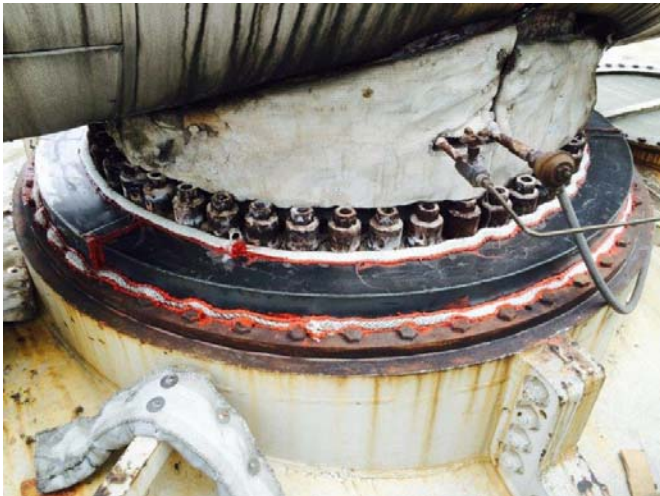
Rolled angle with rope and caulking to seal the gap

The system, operating under a vacuum, will pull down on the rolled angle once the gap is sealed with ceramic rope and high temperature caulk.

This repair needs to be done while the system is hot so that there is no significant thermal growth movement; which will break the seal.

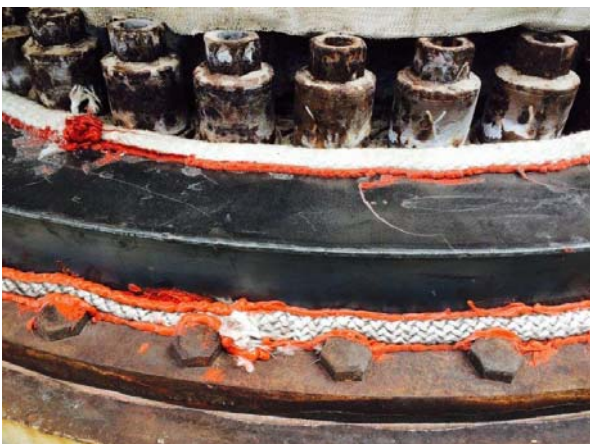
The customer was able to maintain a stronger system vacuum than other attempted methods such as stuffing fire-blanket and sealing putty in the cavity.
